Subject: **Electromagnetic clutches – air gap adjustment**

Annex 1 to Service Bulletin RO-054 Clutch activation procedure

Annex 2 to Service Bulletin RO-054 Electromagnetic Clutch rotor/armature air gap (check and adjustment)

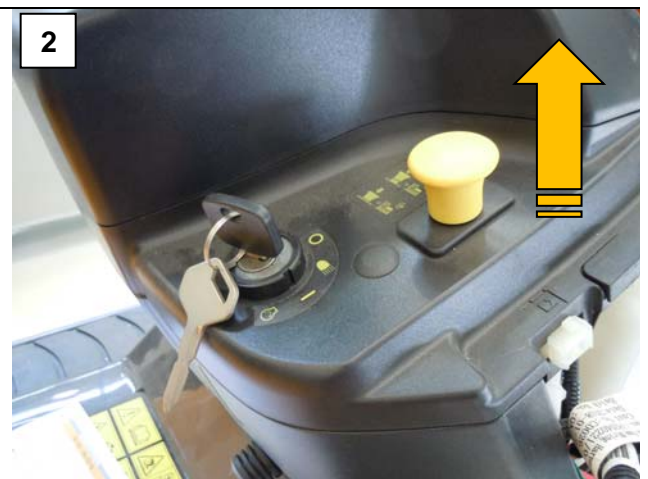
2
Turn the key to ON position and engage the blade, a click must be heard from the clutch

With the key set to «ON», when the switch is operated a click must be heard from the moving part of the clutch, due to excitation of the electric wiring.

If not, check the electric harness integrity and control switch operation.

The clutch must be replaced if cannot engage after these checks.

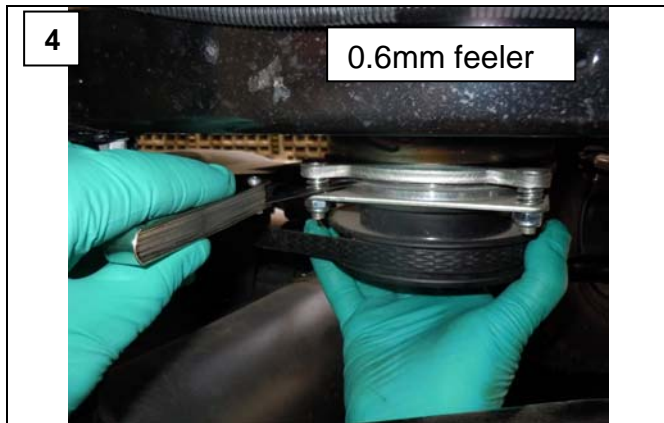
Rotate the clutch for a full 360° turn.
0.6 mm feeler shouldn't go in.
