Subject: **Electromagnetic clutches – air gap adjustment**

## Annex 1 to Service Bulletin RO-054 Clutch activation procedure

## Annex 2 to Service Bulletin RO-054 Electromagnetic Clutch rotor/armature air gap (check and adjustment)

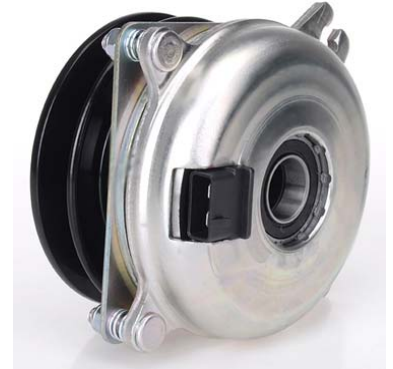
All ride-on models equipped with blades engagement controlled by adjustable electromagnetic clutch (see beside picture as reference).

There have been limited number of reports concerning the electromagnetic clutch not engaging in hot conditions especially after extended working time. The related investigation concluded that the malfunction was due to rotor/armature air gap too large.

There are several possible reasons why the rotor/armature air gap is too large and one of the most probable is the wear due to normal use or caused by frequent blades engagements on high grass with the cutting deck in low position.

Although the too large air gap cannot be attributed to a construction defect, the adjustment can be managed within the 24 months warranty period by setting the air gap according to the given specification. Complete clutch replacement will not be covered by warranty.

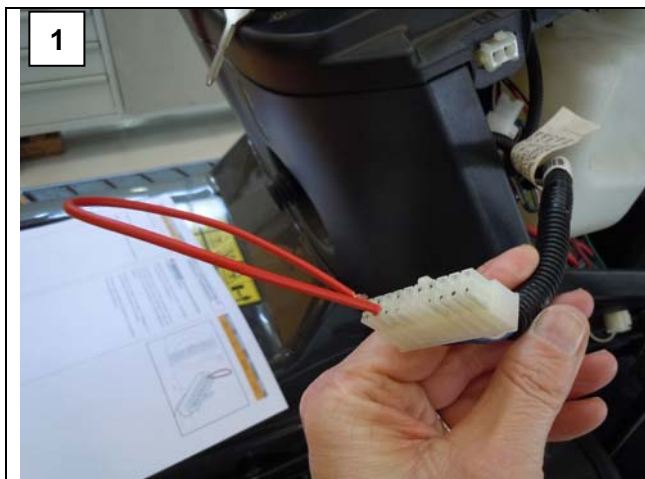
1  
Bridge terminals 2 and 11

Disconnect connector CN1 from the printed circuit board and bridge terminals 2 and 11 of cabling connector CN1 (1).

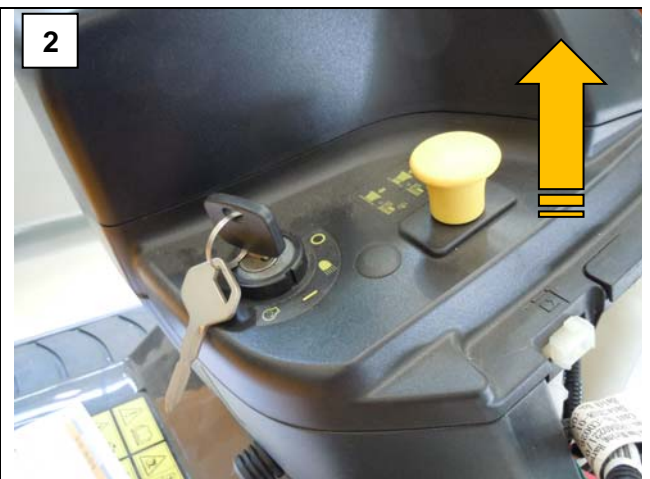
2  
Turn the key to ON position and engage the blade, a click must be heard from the clutch

With the key set to «ON», when the switch is operated a click must be heard from the moving part of the clutch, due to excitation of the electric wiring.

If not, check the electric harness integrity and control switch operation.

The clutch must be replaced if cannot engage after these checks.

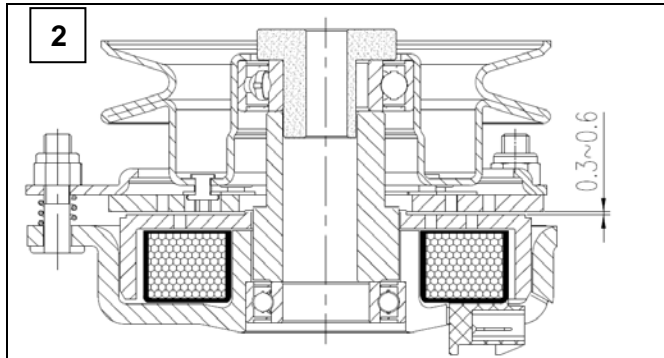
Inspect the air gap with a feeler gauge.  
**NOTE: air gap should be 0,3-0,6 mm**

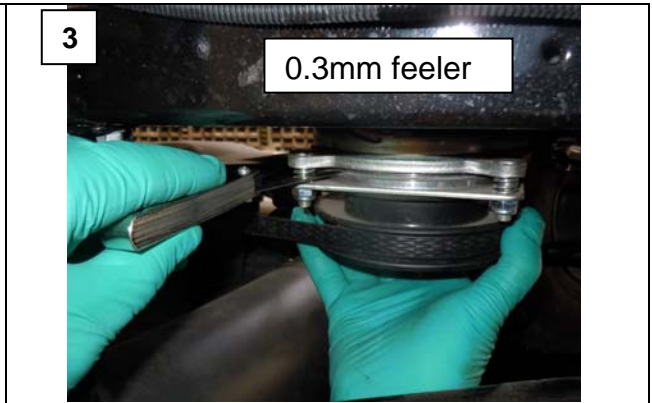
Rotate the clutch for a full 360° turn.  
0.3 mm feeler should go through freely.

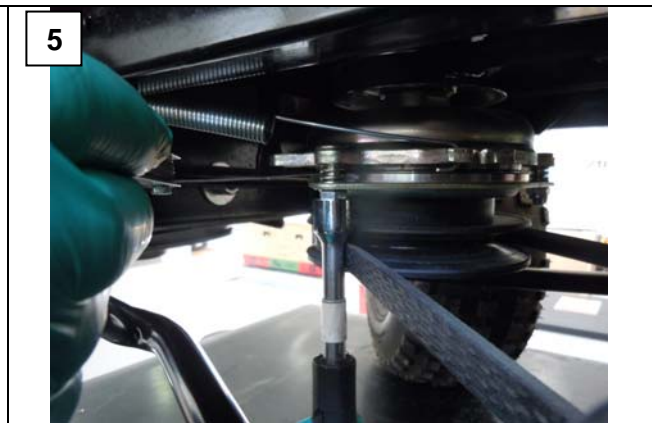
**WARNING:** NEVER adjust the air gap at less than 0,3 mm this could lead to permanent clutching

The air gap can be adjusted by tightening the 3 nuts.  
After adjusting please check the air gap according to step 3 and 4.

**NOTE:** Start the engine and warm it up for a few minutes. Perform 10 blade engagements to confirm the clutch is working properly.
