Subject: **Ride-ons MP84 - 98 – Hydro-Gear transmission water oil contamination**

Attachment to Service Bulletin RO-053 Hydro-Gear T2 – Oil change procedure

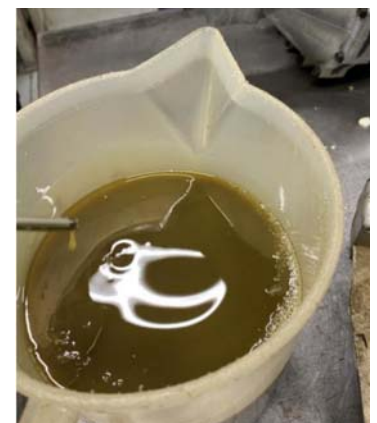
There have been a very limited number of reports that, after 10-20 min of usage, the hydrostatic transmission loses power and makes a high pitch noise. The related investigation concluded that the malfunction was due to *water oil contamination*.

Further tests have shown that even a very small quantity of water (10-15 ml) would be sufficient to negatively affect the hydrostatic transmission performances.

The presence of water mixed with oil can be often recognized by the typical “coffee-latte” (light green & brawn) color that the fluid takes on. Beside pictures clearly show the color of *water contaminated oil*.

2. If the recommended troubleshooting has been performed but the traction power loss is still present, it is possible that the cause of failure might be linked to oil water contamination. In this case **do not replace the transmission** but just change the transmission oil according to the step by step instructions attached to this Service Bulletin.

IMPORTANT: Fill the transmission with 20W50 Motor Oil. **Do not use hydraulic oil!**
