Subject: **Electromagnetic clutches – air gap adjustment**

## Annex 1 to Service Bulletin RO-054 Clutch activation procedure

## Annex 2 to Service Bulletin RO-054 Electromagnetic Clutch rotor/armature air gap (check and adjustment)

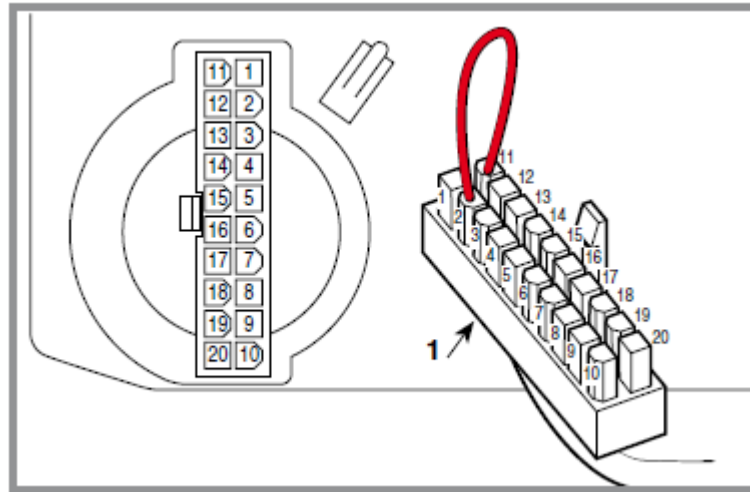
Disconnect connector CN1 from the printed circuit board and bridge terminals 2 and 11 of cabling connector CN1 (1).

With the key set to «ON», when the switch is operated a click must be heard from the moving part of the clutch, due to excitation of the electric wiring.

If not, check the electric harness integrity and control switch operation.

The clutch must be replaced if cannot engage after these checks.
